SSMP AUDITS Training

SSMP PROGRAM AUDITS (Provision D.13(x)) – Order 2006-003-DWQ

Sewer System Management Plan (SSMP)
AUDIT (2017-2022)

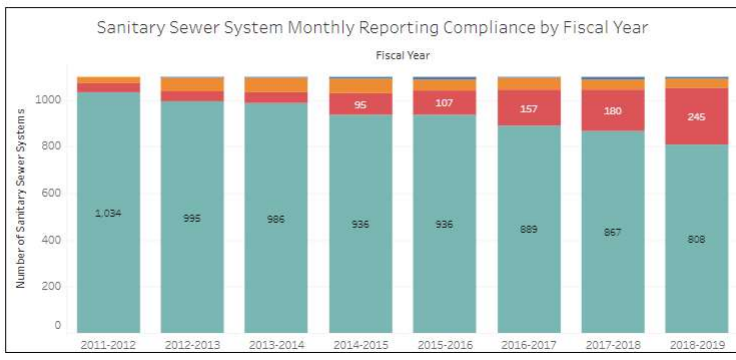
Sanitary Sewer System Monthly Reporting Compliance by Fiscal Year

Fiscal Year	In Compliance	Failed to report	Contradictory rep...	Both failed to rep...
2011-2012	1,034	0	0	0
2012-2013	995	0	0	0
2013-2014	986	0	0	0
2014-2015	936	95	0	0
2015-2016	936	107	0	0
2016-2017	889	157	0	0
2017-2018	867	180	0	0
2018-2019	808	245	0	0

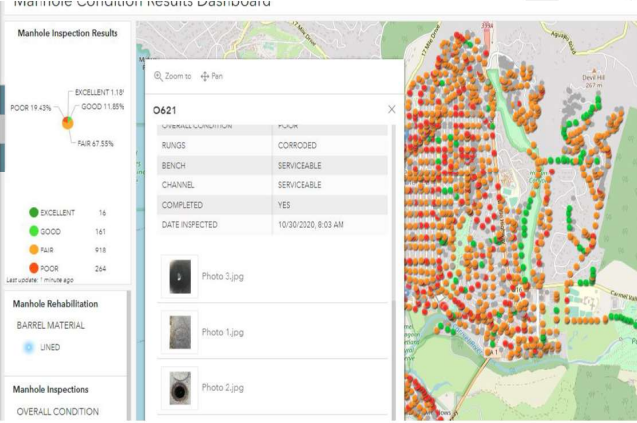
Manhole Condition results Dashboard

CONDITION	COUNT
EXCELLENT	16
GOOD	161
FAIR	918
POOR	254

- Information from Manhole Inspections was displayed to show system conditions.
- A dashboard and infographics were used for reporting to track progress.
- Can give access to bidders to see manhole conditions prior to bidding.

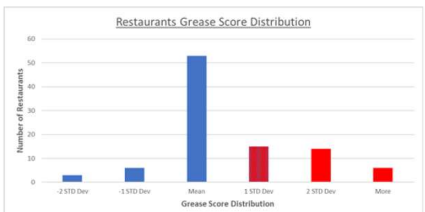
- To analyze which restaurants are discharging grease, data for each line segment in CAWD was totaled for all the downstream line segments associated with each individual restaurant. This provided a unique "grease score" for each restaurant.
- The restaurants with a "grease score" greater than 1 standard deviation above the mean were identified for further investigation. Of the approximately 100 restaurants in the District, 30 were determined to be likely sources of grease observed in the pipelines (i.e. these 30 restaurants had a grease score of greater than one standard deviation above the mean). These restaurants were called "potential problem restaurants".

Grease Score Distribution	Number of Restaurants
-2 STD Dev	5
-1 STD Dev	10
Mean	55
1 STD Dev	15
2 STD Dev	10
More	5

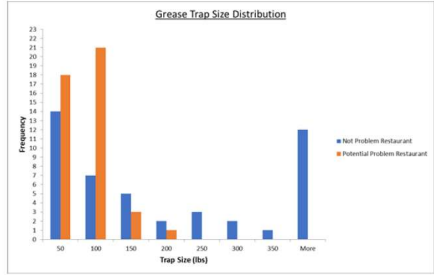
- Grease trap size for each restaurant was also compared to the grease score for each restaurant.
- The analysis of grease trap size and downstream grease score showed that the majority of "potential problem restaurants" with a grease trap size less than 150 lbs were on the list.
- Only 4 of the identified "potential problem restaurants" had grease trap sizes of 150 lbs or larger.

Trap Size (lbs)	Frequency (Not Problem Restaurant)	Frequency (Potential Problem Restaurant)
50	14	18
100	7	22
150	4	5
200	2	1
250	2	0
300	1	0
350	1	0
More	12	0

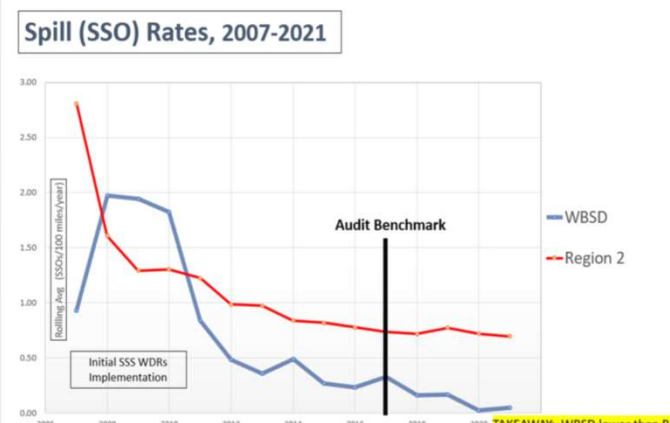
Spill (SSO) Rates, 2007-2021

TAKEAWAY: WBSD lower than Region past 10 years
